EXHIBIT A:
FBS Joint Storm Damage Report

Joint Storm Damage Report

**Forest Ridge Homeowners Association
1551 Yellowstone Drive**

FIELD REPORT FOR INITIAL STORM DAMAGE INVESTIGATION

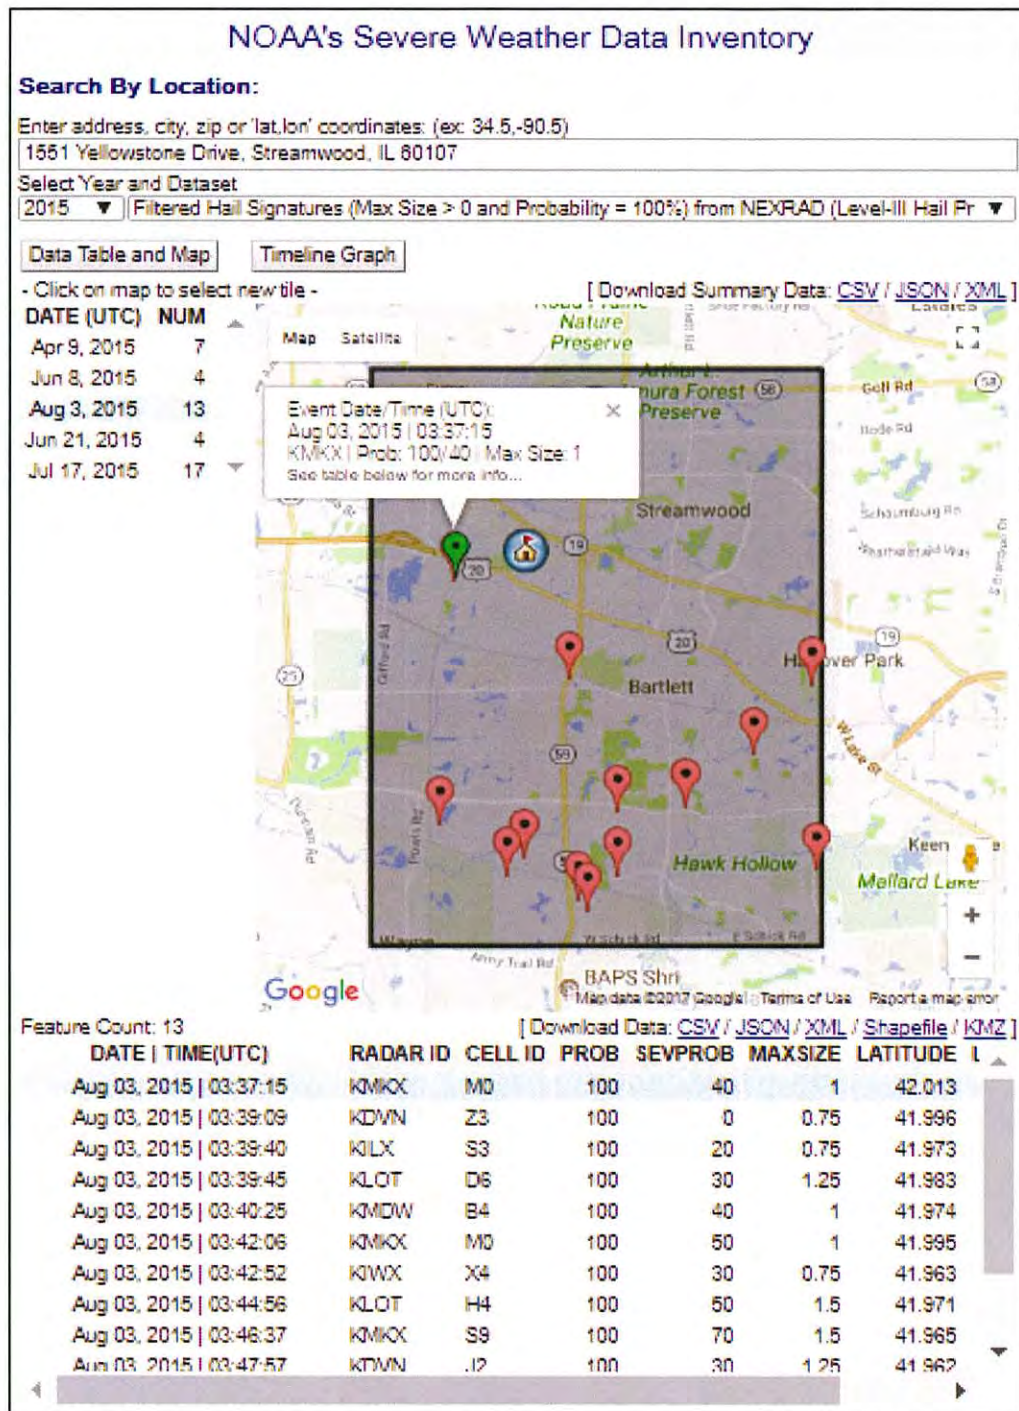
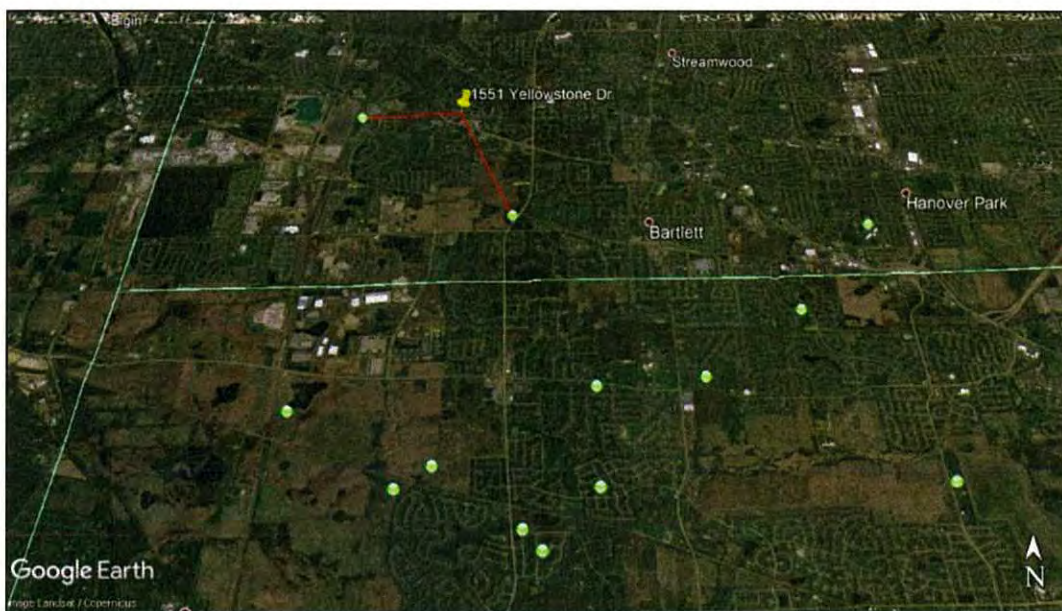
1.3 NOAA Severe Weather Data for Filtered Hail Signatures on August 2, 2015:

Note: Times are listed in Universal Time (UTC), which is 5 hours ahead of Streamwood's Central Time. Therefore, reported time of 03:37 on August 3, 2015 can be converted to 22:37 on August 2, 2015.

Google Earth imagery of filtered hail signatures (green dots) reported on August 2, 2015. The hail signature to the west is 0.85 miles away from the property and the hail signature to the southeast is 1.30 miles away from the property.

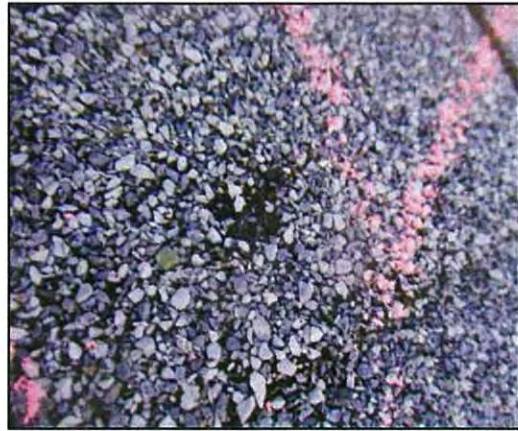
Figure 2.

- Impact damage to window screens.
- Impact damage to gutter.
- Missing shingle tab.
- 20+ impacts identified on the south facing roof slope.
- 20+ impacts identified on the north facing roof slope.

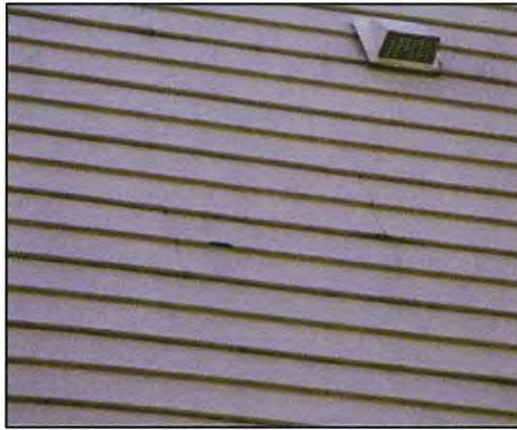
Figure 5.

- Impact damage to vinyl siding.
- 20+ impacts identified on the south facing roof slope.
- 20+ impacts identified on the north facing roof slope.
- This building also inspected a 2nd time, on November 9, 2017 by Tom Irmiter.
 - The following observations were made at that time:
 - Front Center area: 10+ impacts from hail.
 - Back: 12+ impacts from hail.
 - Siding pulled back: No manufacturer identifying marks found.
 - Siding in contact with roofing.

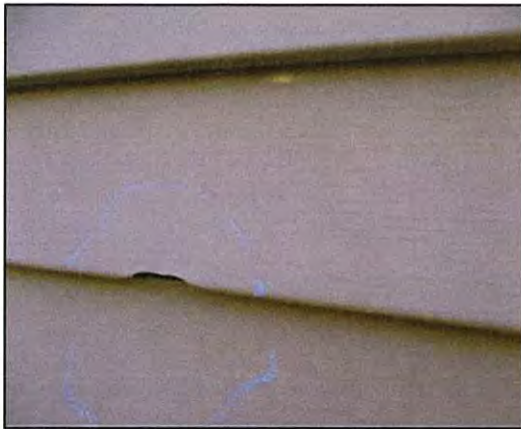
Figure 8.

- This building inspected on October 16, 2017 by Brian Johnson, P.E. and Kevin Steinke. The following observations were made at that time.
- Impact damage to gutter and downspouts.
- Impact damage to metal light fixture (see fig. 10 of photo log).
- Impact damage to vinyl siding.
- Detached vinyl siding identified.
- Small part of roof tarped over.
- Missing shingle tab.
- 20+ impacts identified on the south facing roof slope.
- 20+ impacts identified on the north facing roof slope.

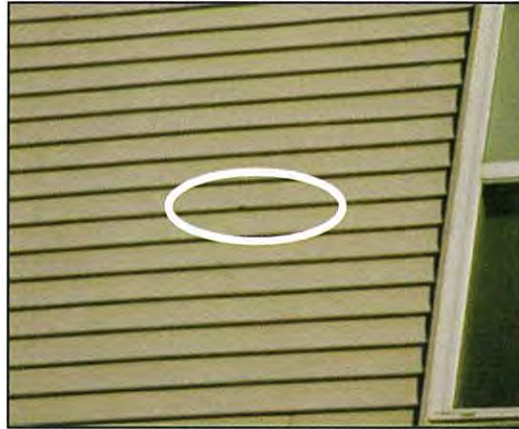
Figure 13.

- Impact damage to vinyl siding.
- Impact damage to gutter.
- 20+ impacts identified on the east facing roof slope.
- 20+ impacts identified on the west facing roof slope.

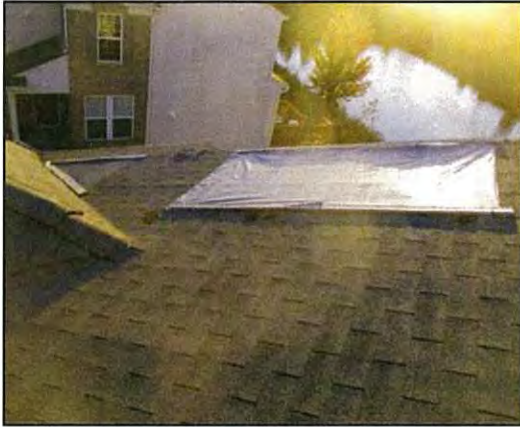
Figure 16.

- Impact damage to gutter and downspout.
- Buckling of the roof deck was observed.
- Tarped off section of roof slope observed.
- Impact damage to drip cap above window.
- 20+ impacts identified on the southeast facing roof slope.
- 20+ impacts identified on the northwest facing roof slope.
- This building also inspected a 2nd time, on November 9, 2017 by Tom Irmiter.

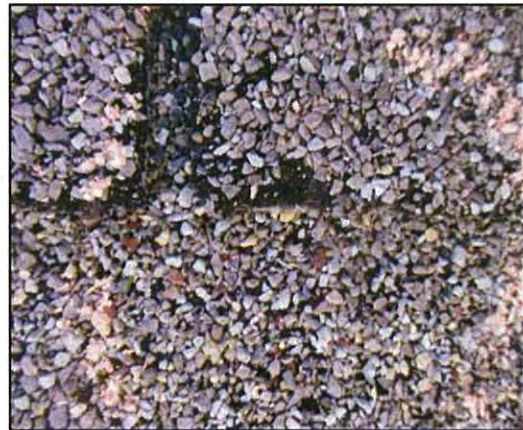
Figure 22.

- Impact damage to gutter.
- 20+ impacts identified on the south facing roof slope.
- 20+ impacts identified on the north facing roof slope.

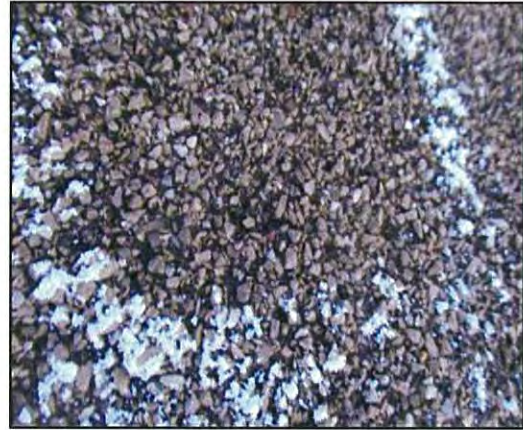
Figure 72.

- Impact damage to gutter and downspouts.
- Minimal impact to A/C condenser coils.
- Nail pop identified.
- 20+ impacts identified on the northeast facing roof slope.

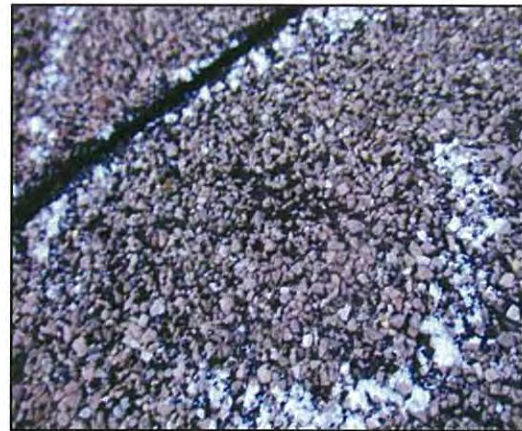
Figure 76.

- Impact damage to gutter.
- Mechanically damaged shingle identified.
- 20+ impacts identified on the northwest facing roof slope.
- 20+ impacts identified on the southeast facing roof slope.

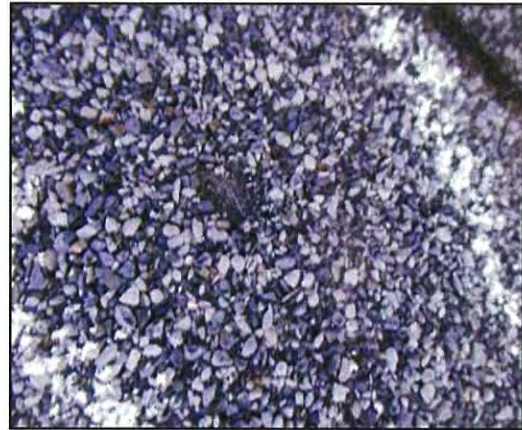
Figure 80.

- Impact damage to gutter.
- Minimal impact damage to A/C condenser coils.
- Nail pop identified.
- Mechanically damaged shingle identified.
- 10 impacts identified on the northwest facing roof slope.
- 12 impacts identified on the southeast facing roof slope.
- This building also inspected a 2nd time, on November 9, 2017 by Tom Irmiter.
The following observations were made at that time:
 - Visible hail damage from hail on roof. No sample squares were done.

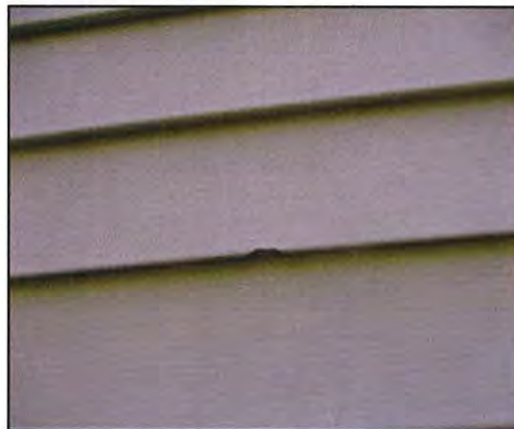
Figure 83.

- Impact damage to gutter.
- Impact damage to vinyl siding.
- 20+ impacts identified on the southeast facing roof slope.
- 20+ impacts identified on the northwest facing roof slope.

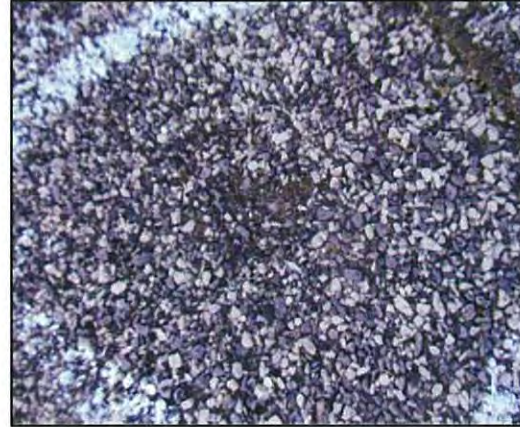
Figure 85.

- Mechanically damaged shingle identified.
- 9 impacts identified on the southwest facing roof slope.
- 9 impacts identified on the northeast facing roof slope.
- This building also inspected a 2nd time, on November 9, 2017 by Tom Irmiter.
The following observations were made at that time:
 - Front: 15 impact locations in 10 x 10 area
 - Back: 16 impact locations in 10 x 10 area

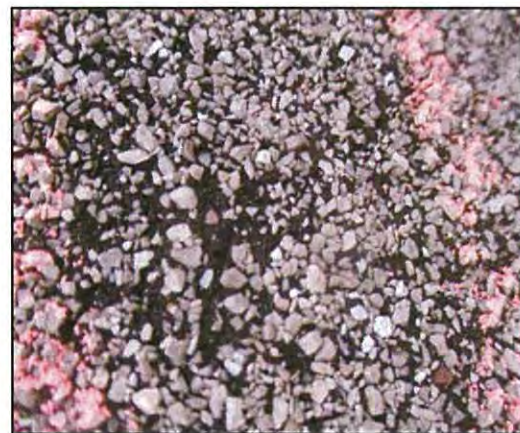
Figure 87.

- Impact damage to gutter.
- Mechanically damaged shingle identified.
- 20+ impacts identified on the northeast facing roof slope.
- 20+ impacts identified on the southwest facing roof slope.
- This building also inspected a 2nd time, on November 9, 2017 by Tom Irmiter.
The following observations were made at that time:
 - Front 10+ impact locations on dormer.

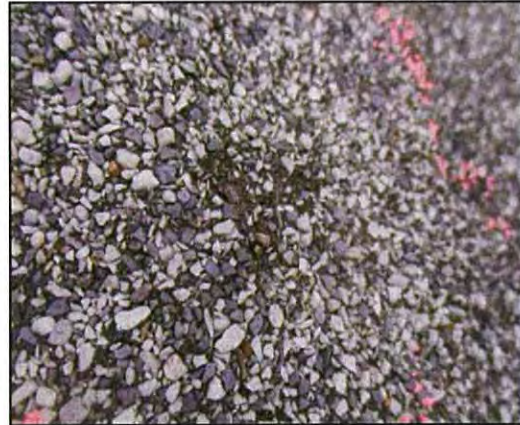
Figure 89.

- Impact damage to gutter.
- 15 impacts identified on the southwest facing roof slope.
- 5 impacts identified on the northeast facing roof slope.

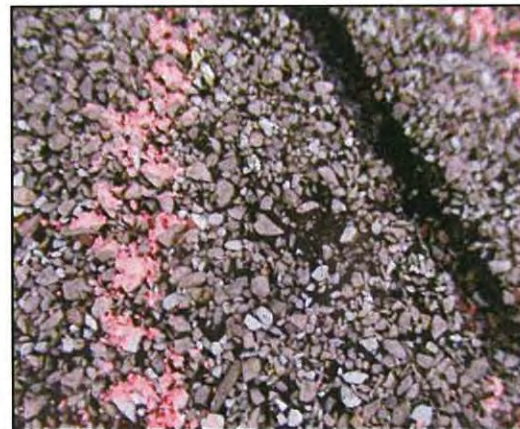
Figure 91.

- Impact damage to gutter.
- Impact damage to vinyl siding.
- Mechanically damaged shingles identified.
- 20+ impacts identified on the east facing roof slope.
- 20+ impacts identified on the west facing roof slope.

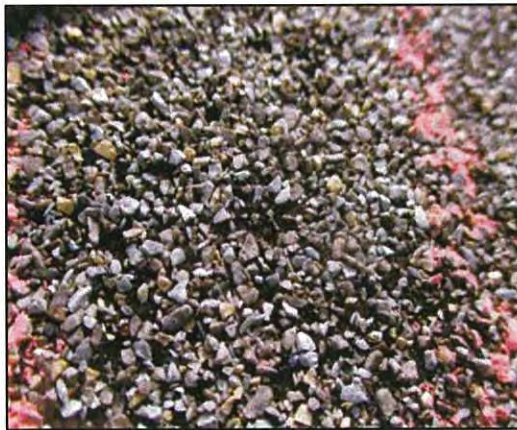
Figure 93.

- Detached vinyl siding identified.
- 20+ impacts identified on the southwest facing roof slope.
- 20+ impacts identified on the northeast facing roof slope.
- This building also inspected a 2nd time, on November 9, 2017 by Tom Irmiter.
The following observations were made at that time:
 - Front: 12+ impact locations in 10 x 10 area.

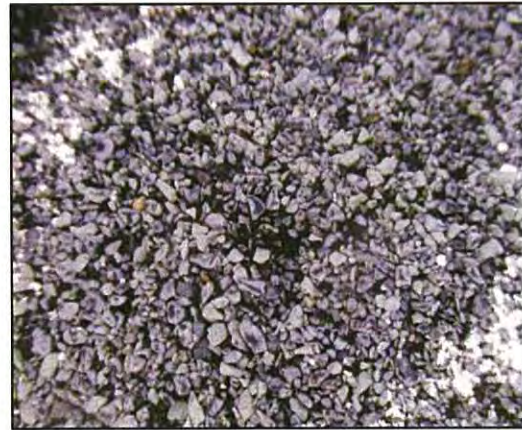
Figure 97.

- Impact damage to gutter and downspouts.
- 10 impacts identified on the southwest facing roof slope.
- 12 impacts identified on the northeast facing roof slope.

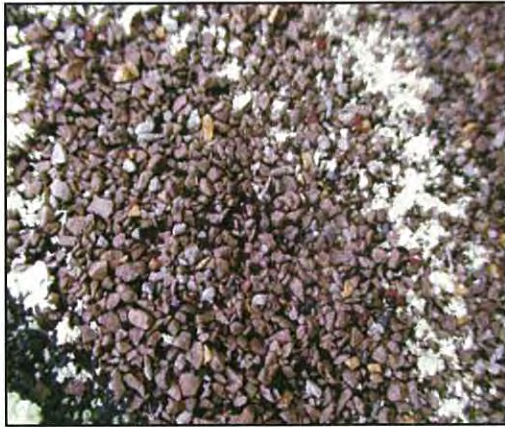
Figure 98.

- 20+ impacts identified on the southwest facing roof slope.
- 20+ impacts identified on the northeast facing roof slope.

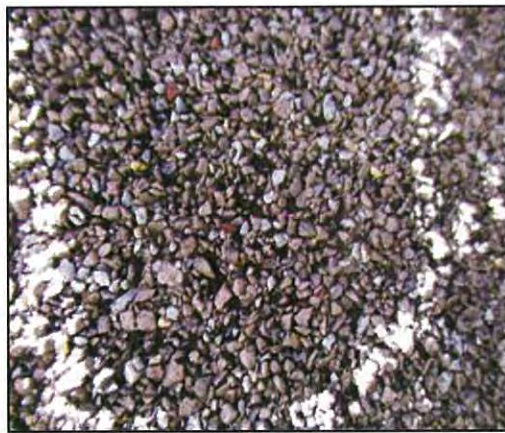
Figure 100.

- 20+ impacts identified on the east facing roof slope.
- 20+ impacts identified on the west facing roof slope.
- This building also inspected a 2nd time, on November 9, 2017 by Tom Irmiter. The following observations were made at that time:
 - Front: 16+ impact locations in 10 x 10 area.
 - Back: 15+ impact locations in 10 x 10 area.

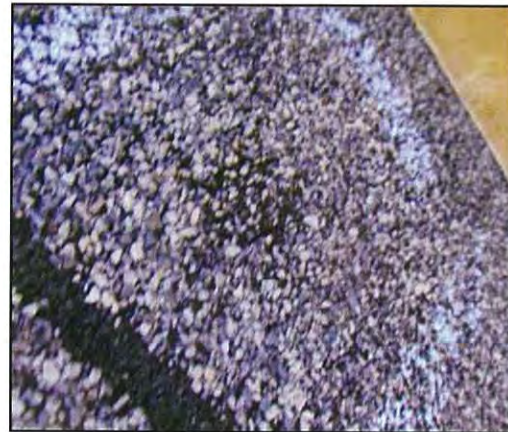
Figure 103.

- This building inspected on October 16, 2017 by Brian Johnson, P.E. and Kevin Steinke. The following observations were made at that time:
- Impact damage to gutter and downspouts.
- Mechanically damaged shingle identified.
- Impact damage to metal flashing identified.
- 13 impacts identified on the east facing roof slope.
- 12 impacts identified on the west facing roof slope.
- This building also inspected a 2nd time, on November 9, 2017 by Tom Irmiter. The following observations were made at that time:
 - Granular loss in gutter.

- Front: 10+ impact marks in 10 x 10 area.
- Back: many impact marks from hail.
- Back: 2 locations with manufacturing/install damage equaling 2 bundles of shingles.

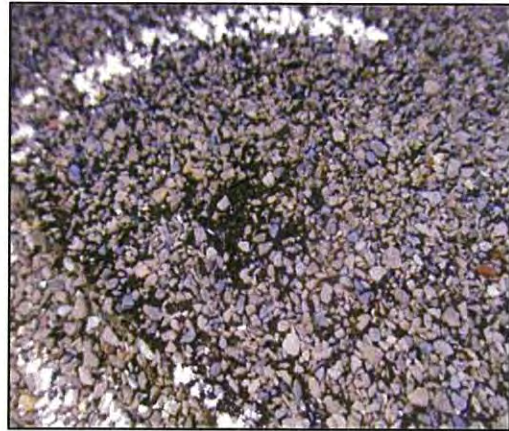
Figure 106.

- Impact damage to gutter.
- 20+ impacts identified on the southwest facing roof slope.
- 20+ impacts identified on the northeast facing roof slope.

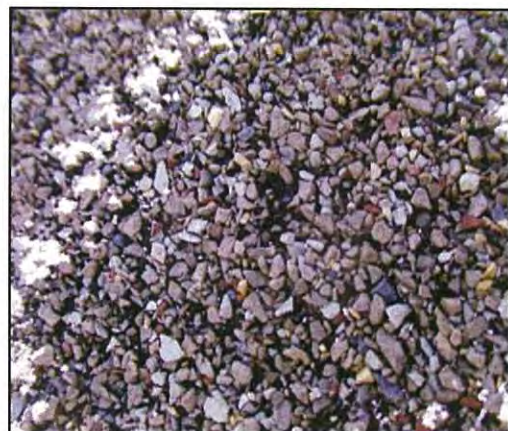
Figure 108.

- Impact damage to gutter and downspout.
- Mechanically damaged shingle identified.
- 20+ impacts identified on the northeast facing roof slope.
- 20+ impacts identified on the southwest facing roof slope.

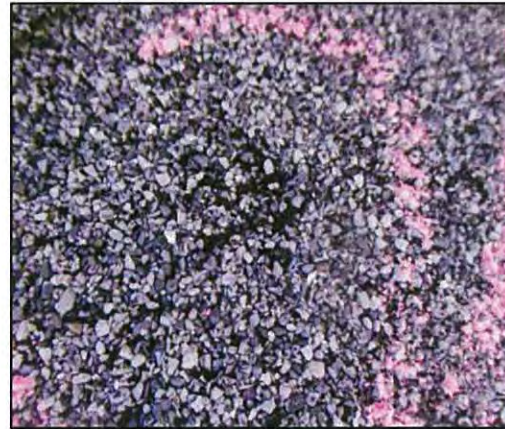
Figure 110.

- Impact damage to gutter.
- 10 impacts identified on the northeast facing roof slope.
- 15 impacts identified on the southwest facing roof slope.

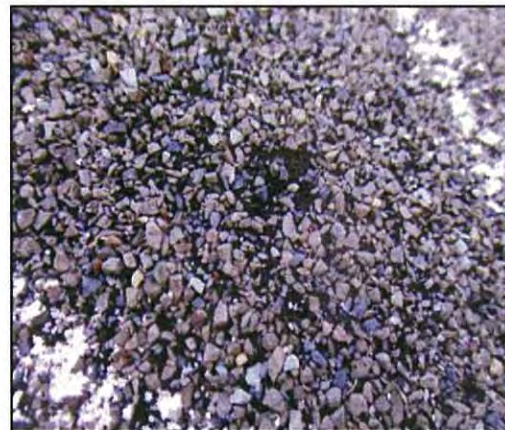
Figure 112.

- Impact damage to gutter.
- Impact damage to metal flashing.
- Roof tarped over in a few areas.
- Replacement shingles identified.
- 20+ impacts identified on the southwest facing roof slope.
- 20+ impacts identified on the northeast facing roof slope.
- This building also inspected a 2nd time, on November 9, 2017 by Tom Irmiter.
The following observations were made at that time:
 - Tarps viewed on roof.
 - Wind damage easily seen from ground.

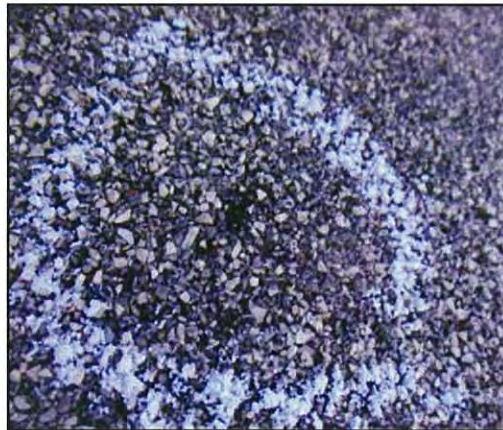
Figure 116.

- This building inspected on October 16, 2017 by Brian Johnson, P.E. and Kevin Steinke. The following observations were made at that time:
- Impact damage to gutter.
- Mechanically damaged shingle identified.
- 20+ impacts identified on the west facing roof slope.
- 20+ impacts identified on the east facing roof slope.

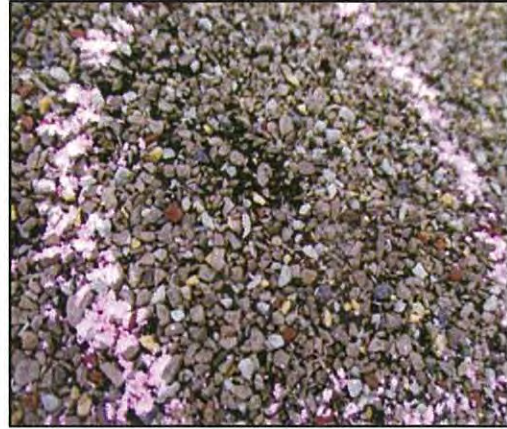
Figure 118.

- Impact damage to gutter and downspouts.
- Detached/displaced piece of vinyl siding.
- 20+ impacts identified on the southwest facing roof slope.
- 20+ impacts identified on the northeast facing roof slope.

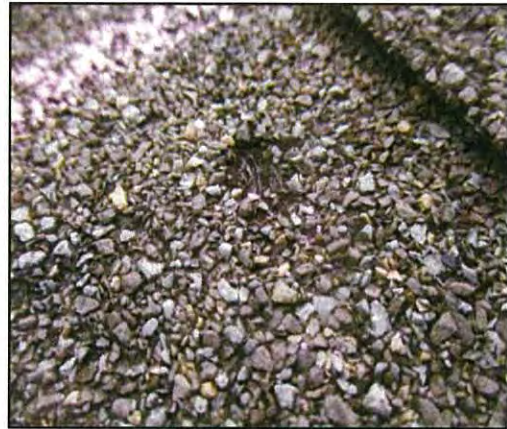
Figure 121.

- Impact damage to gutter and downspouts.
- Impact damage to vinyl siding.
- Detached vinyl siding.
- Mechanically damaged shingle identified.
- 20+ impacts identified on the southeast facing roof slope.
- 13 impacts identified on the northwest facing roof slope.

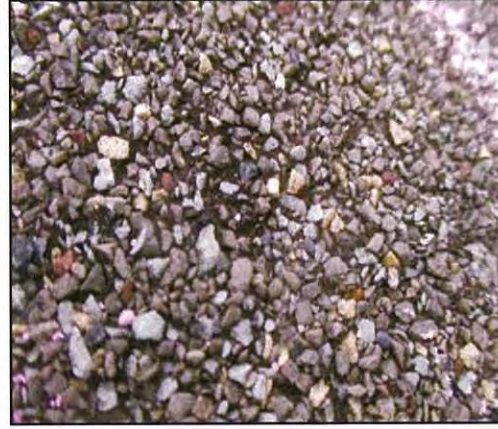
Figure 125.

- Impact damage to gutter and downspout.
- Impact damage to vinyl siding.
- Nail pop identified.
- 20+ impacts identified on the southeast facing roof slope.
- 13 impacts identified on the northwest facing roof slope.

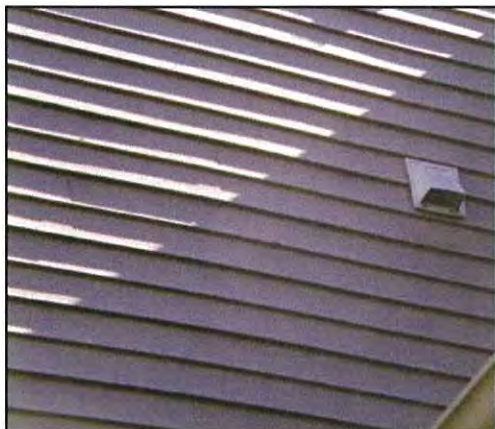
Figure 130.

- Impact damage to gutter.
- Impact damage to vinyl siding.
- 20+ impacts identified on the northwest facing roof slope.
- 20+ impacts identified on the southeast facing roof slope.
- This building also inspected a 2nd time, on November 9, 2017 by Tom Irmiter.
The following observations were made at that time:
 - Front: 14+ impacts from hail in 10 x 10 area.
 - Back: 20+ impacts from hail in 10 x 10 area.

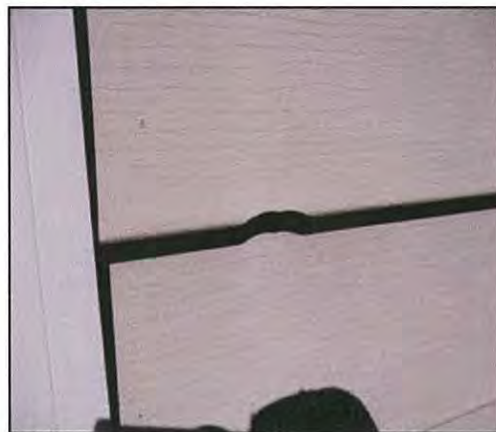
Figure 134.

- Impact damage to gutter.
- Impact damage to vinyl siding.
- 6 impacts identified on the northwest facing roof slope.
- 6 impacts identified on the southeast facing roof slope.

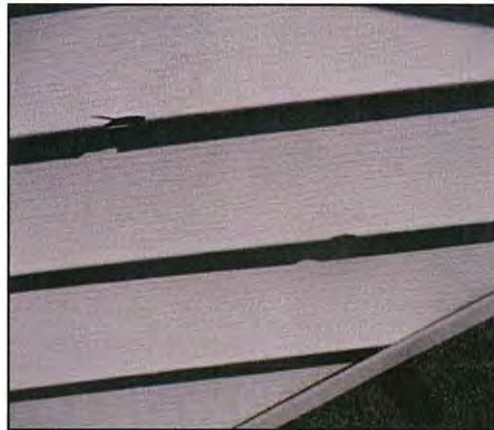
Figure 137.

- Impact damage to gutter and downspout.
- Impact damage to vinyl siding.
- Tarped off sections of roof slopes observed.
- Missing shingle tab identified.
- Detached vinyl siding.
- 20+ impacts identified on the northwest facing roof slope.
- 20+ impacts identified on the southeast facing roof slope.

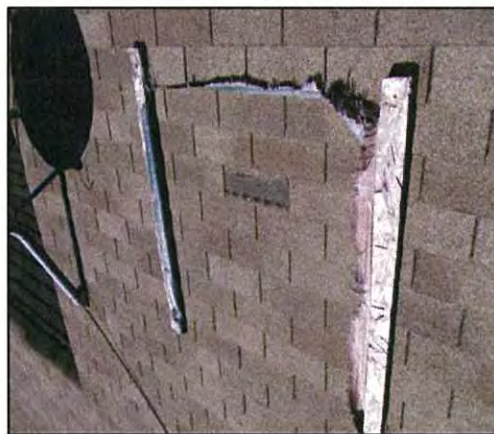
Figure 142.

- Impact damage to gutter.
- Tarped off sections of roof slopes observed.
- Missing shingle tab identified.
- 20+ impacts identified on the southeast facing roof slope.
- 16 impacts identified on the northwest facing roof slope.

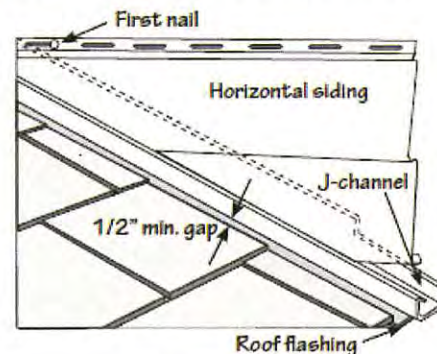
Figure 35.

NOTE: Vinyl J-channels should not be in direct contact with roofing shingles, since the shingles may transfer enough heat to the vinyl J-channel to cause its distortion.

- Fasten the nail, screw, or staple that is closest to the roof line at the far end of the nail hem slot, to ensure that siding will expand away from the J-channel (Fig. 35).
